F-6-54

Willard Farm

Thurmont vicinity, Maryland

Maryland Historical Trust
State Historic Sites Inventory Form

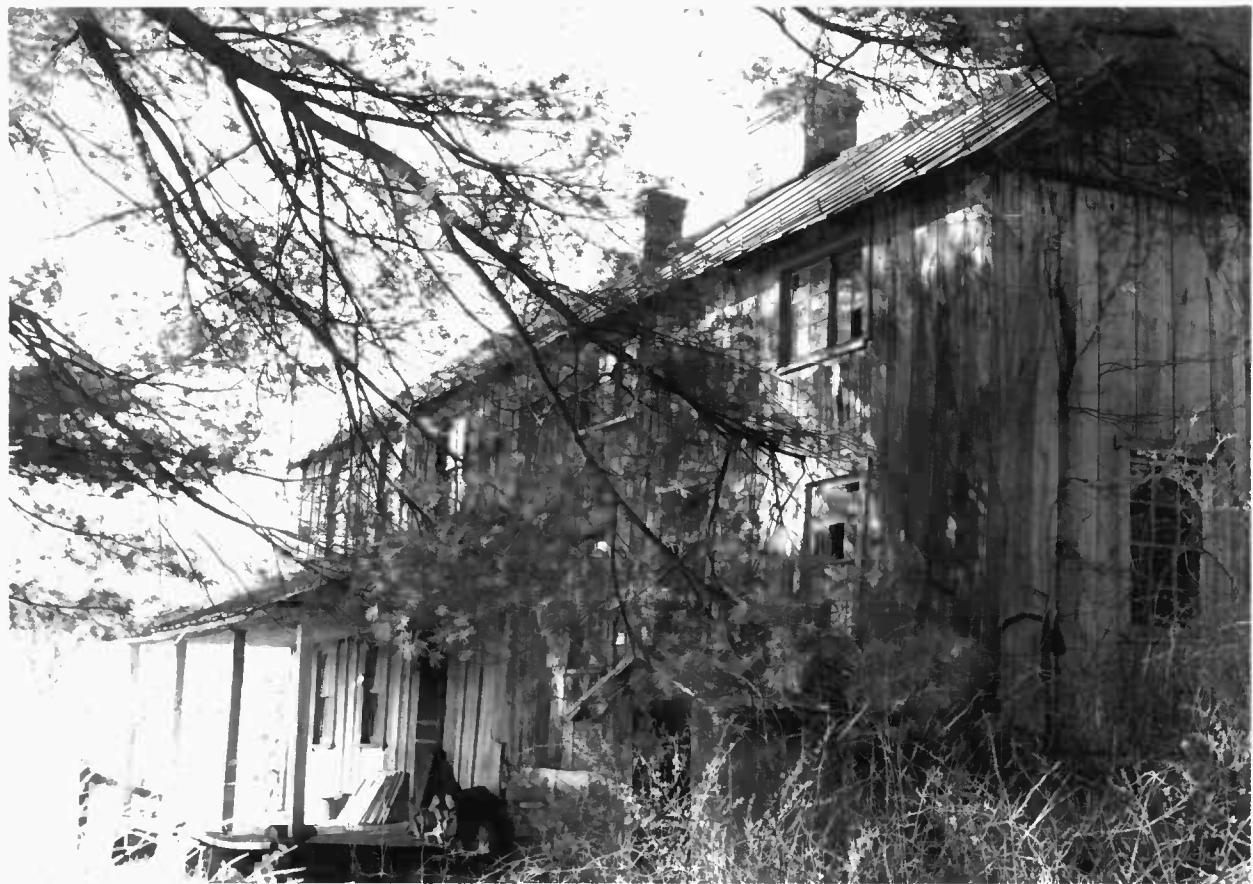
1/5

North-east corner view

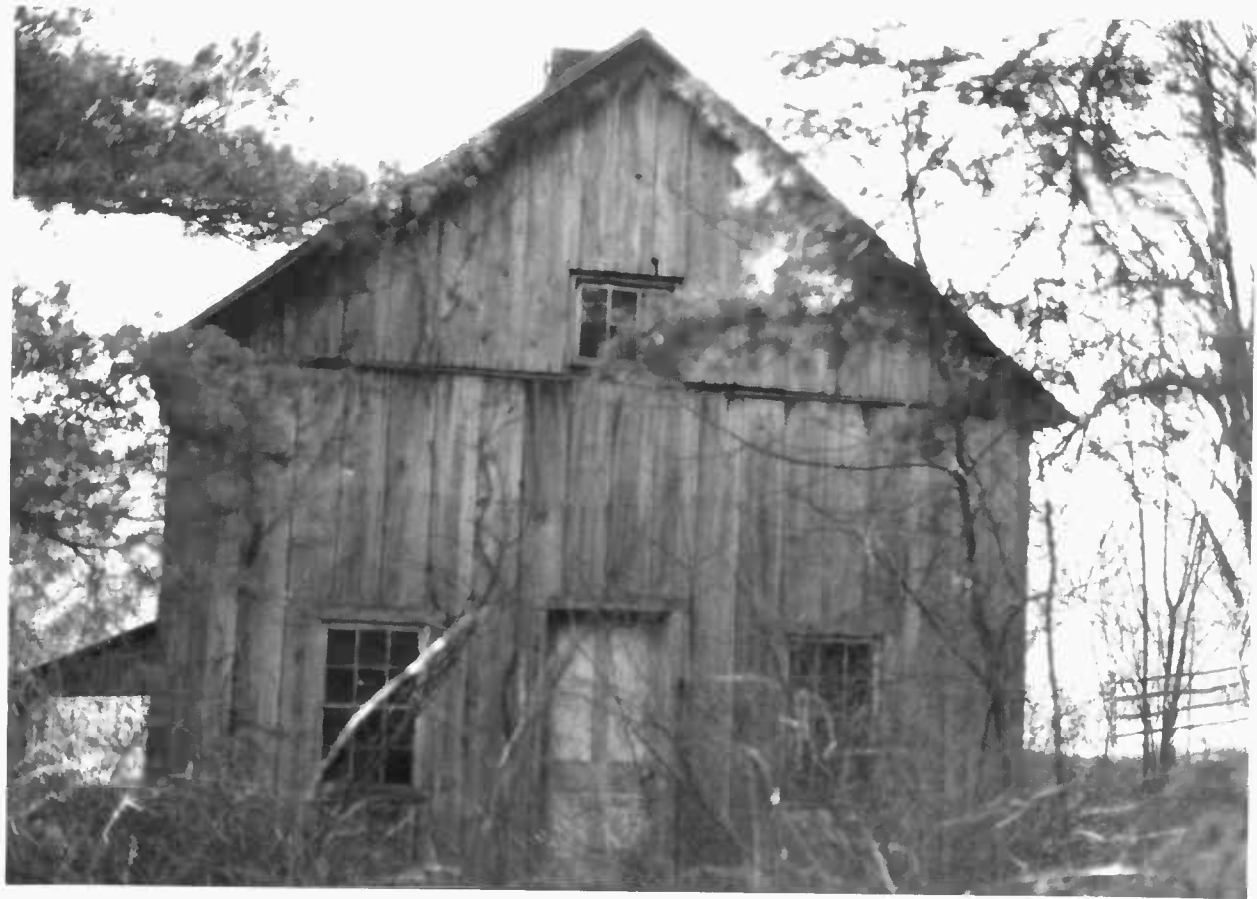
The west elevation contains two 6/6 light windows in the older section and one 2/2 light window in the new section with asymmetrical placement. The north elevation has a central raised panelled door with two 6/6 light windows on the first floor and a 6 light fixed window in the attic. The south elevation reveals heavy logs underneath the siding. A smaller board and batten siding is utilized in the gable end which also has a 6 light fixed window. The first and second stories have symmetrically placed 2/2 light windows. The interior of the building was not accessible.

North elevation

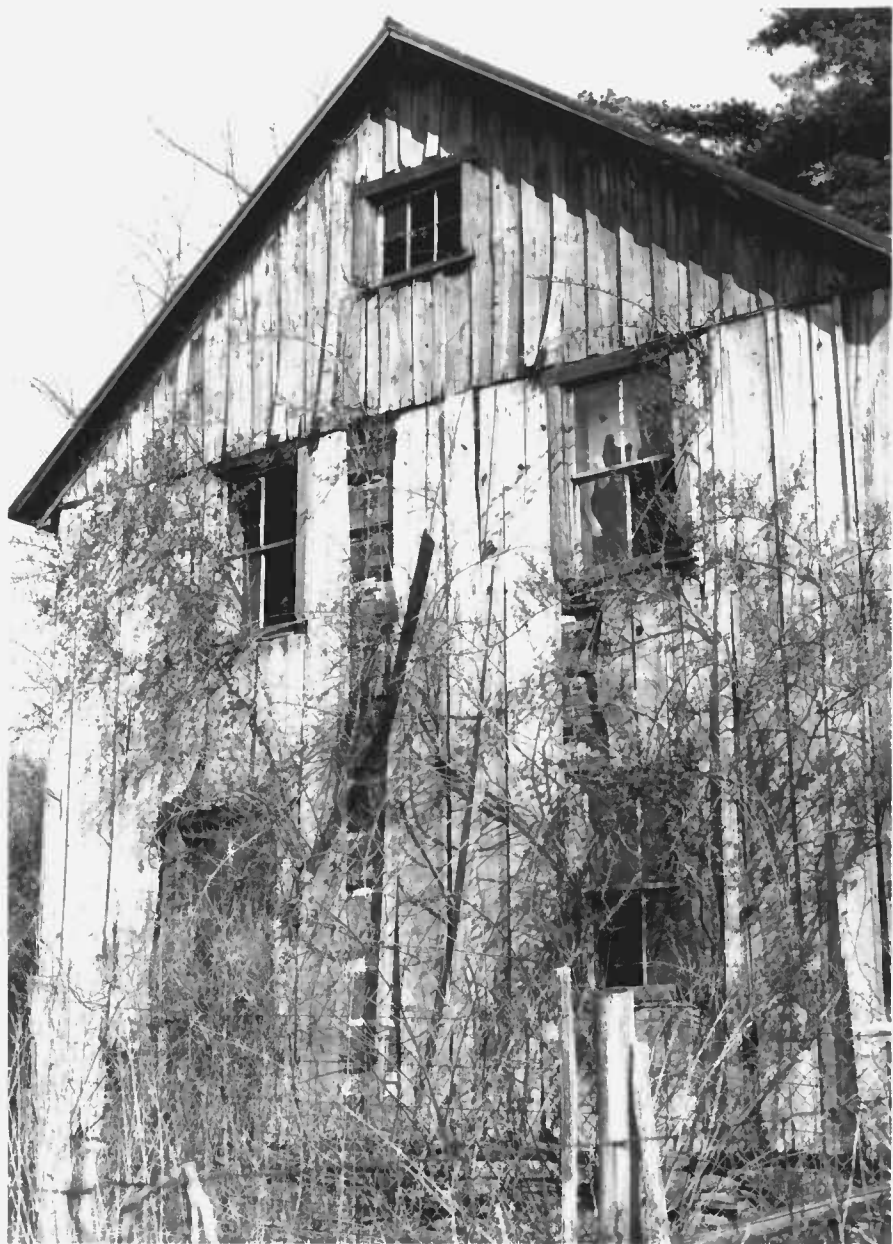
Constructed in two sections, both sections are log with board and batten covering the newer section on the south side and vertical siding sheathing the older section. The side gable roof has three brick chimneys: two interior chimneys located a couple of feet from each end and one central chimney. Both sections of the house rest on a raised stone foundation. Fenestration throughout is comprised of simple window surrounds. In the oldest section (to the north), the east elevation contains a central door with a bible cross and raised panels and two 6/6 light windows on the first floor; the second story has two 6 light sliding casement windows. The raised stone foundation contains a gabled cellar entry hood. The chimney on the north end contains an arched cap. The newer section to the south has symmetrical placement of three bays with a side door and 2/2 light windows on both floors. A one story shed roof porch runs the full facade and has chamfered posts resting on stone piers.

South elevation - exposed log

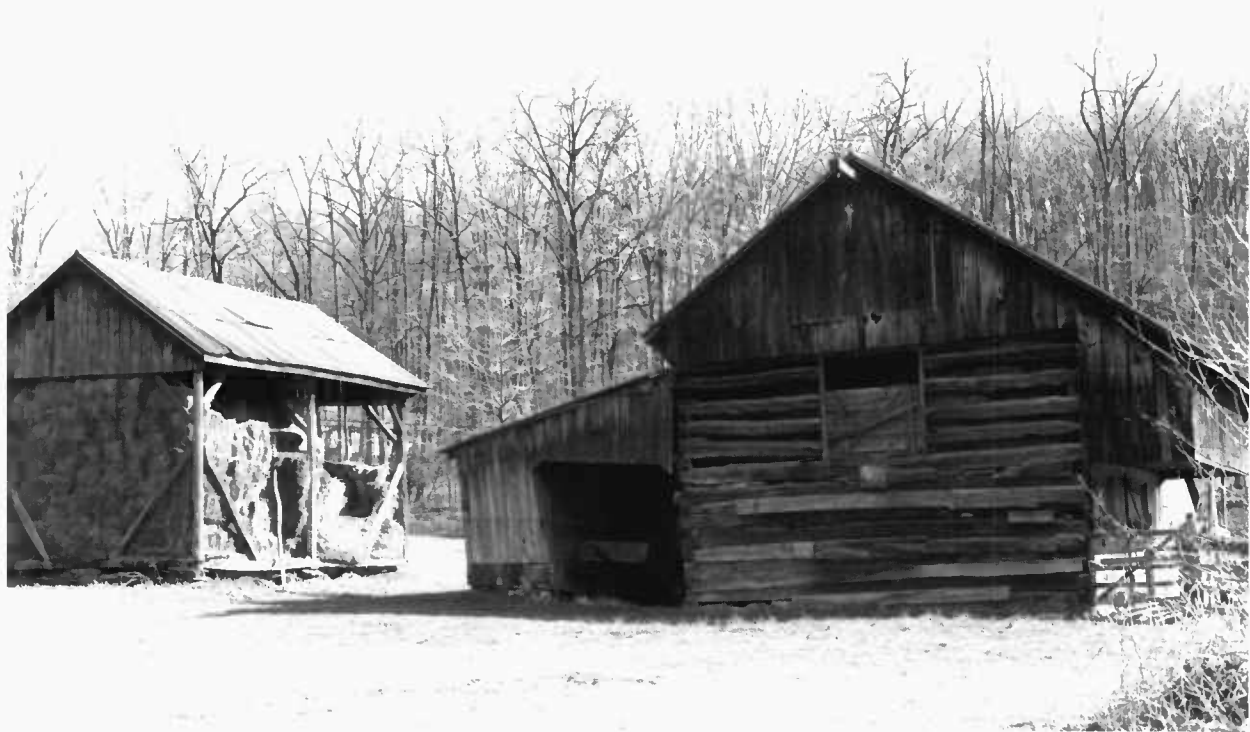
Other buildings with the house include a gabled roofed outhouse located several feet east of the house. Further east, a frame wood shed is situated with an exterior chimney of stone and brick. A log barn is located to the northeast of the house with its gable roof running east to west. It is sheathed in vertical siding. A hay barn and a tractor shed are also located in the complex. A vertical sided corncrib is located to the north of the barn.

Log barn, hay barn - looking east

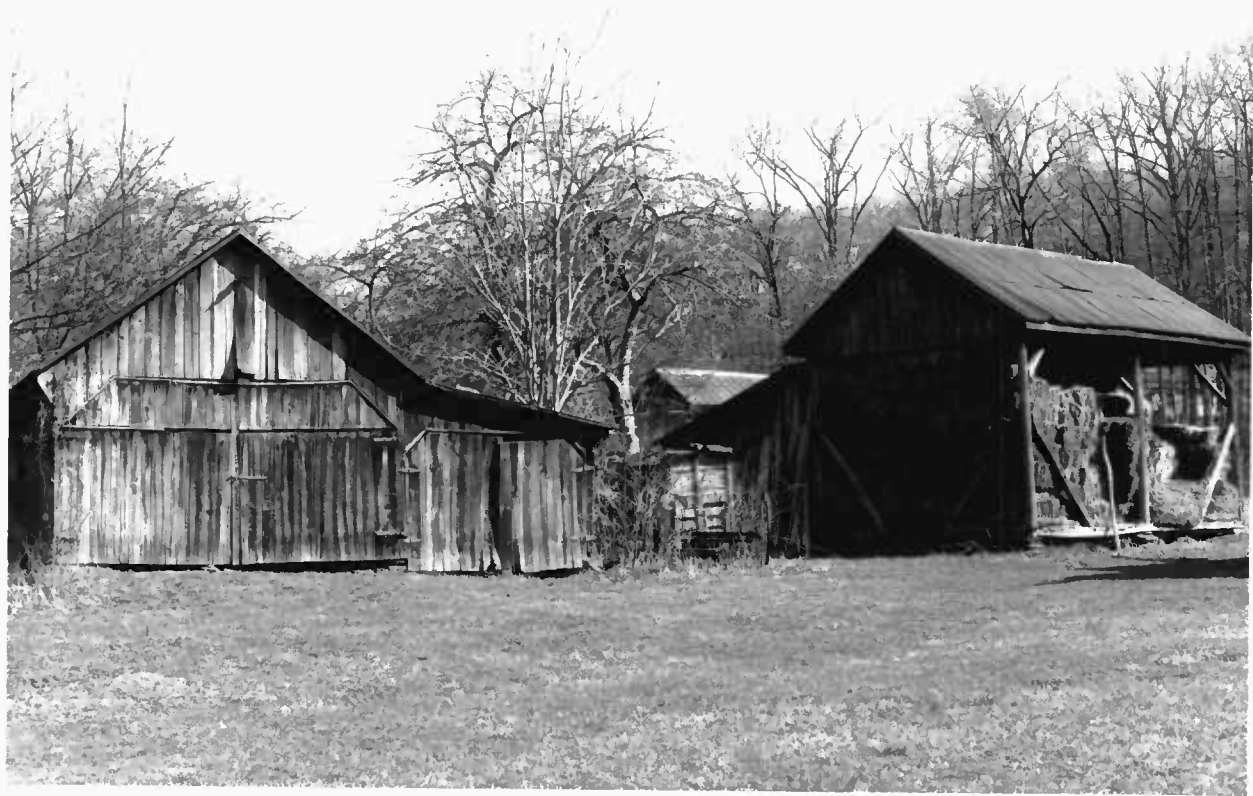
Tractor shed, hay barn - looking north
